City of Alexandria Storm Sewer Capacity Analysis (CASSCA) Corrugated Metal Pipe Condition Assessment

PREPARED FOR: City of Alexandria, CH2M Hill
PREPARED BY: Michael Baker Jr., Inc.
DATE: November 16, 2013

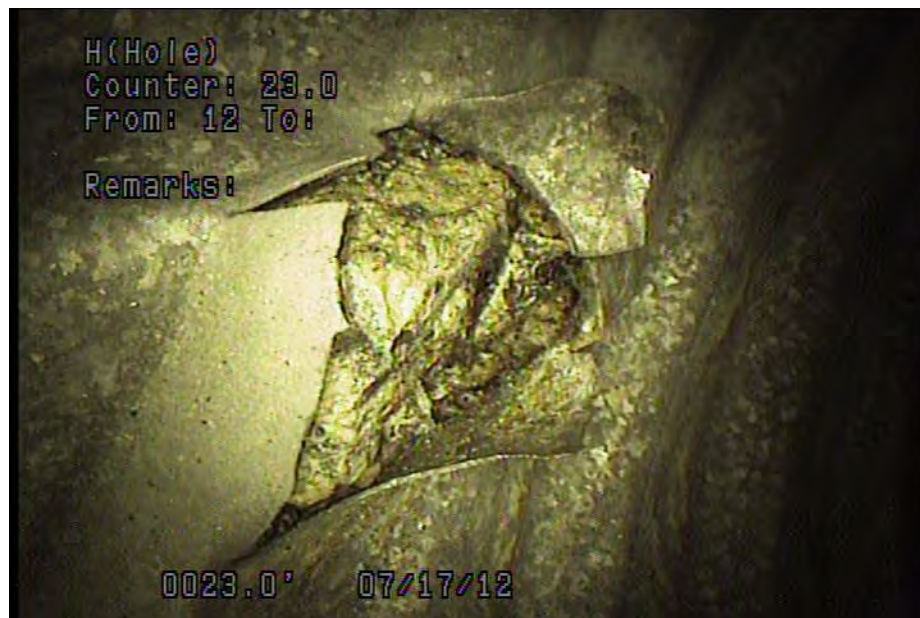
Figure 5. Hole in Pipe Wall.
Segment 007740STMP, Hooffs Run, SCREAM Score = 89

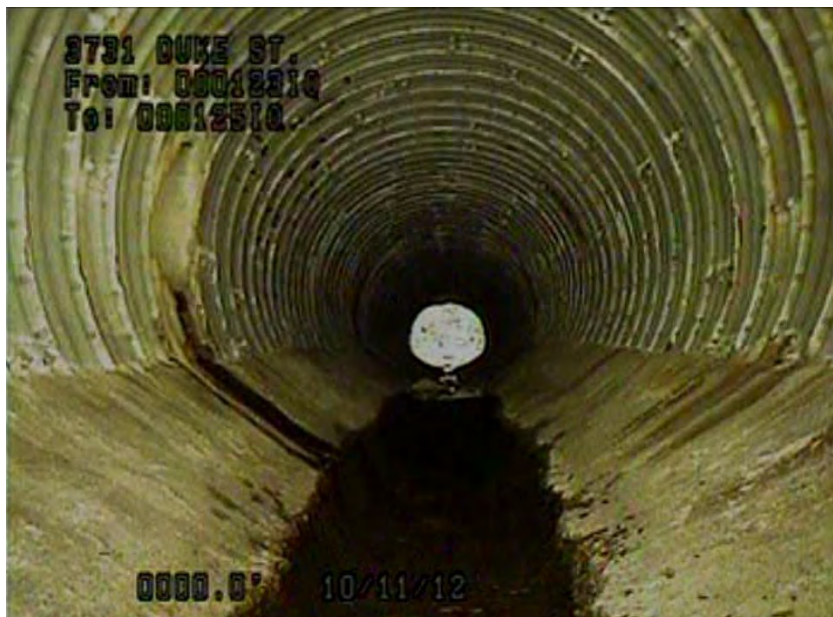
Figure 10. Surface Corrosion and Settled Gravel Deposits.
Segment 003268STMP, Strawberry Run, SCREAM Score = 80

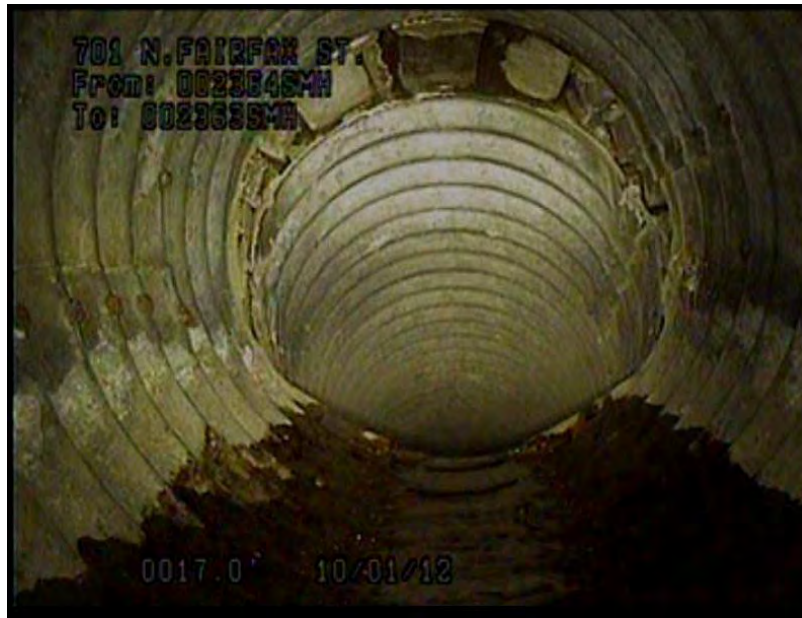
Figure 11. Large Joint Separation,.
Segment 007343STMP, Potomac River Sewershed, SCREAM Score = 100

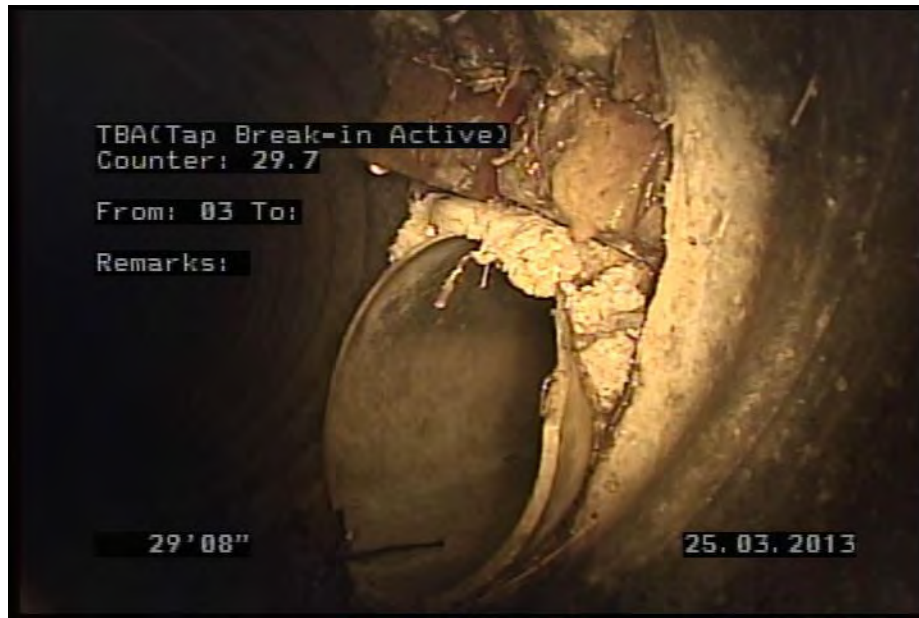
Figure 13. Tap Break-In & Infiltration.
Segment 007847STMP, CSO-Pendleton, SCREAM Score = 42
